Manhole Inspection Summary

Manhole # S41CC_070MH

Location Address: **1505 ashland ave**

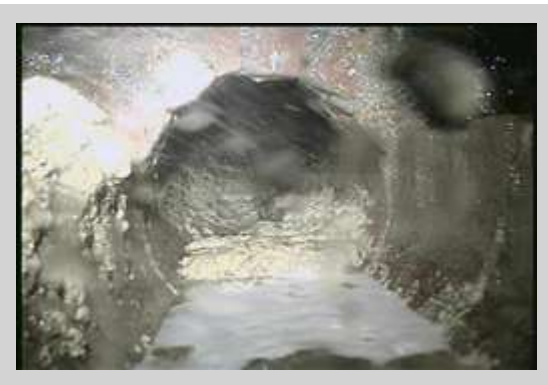
4 O'Clock Inflow

Invert Depth: **15.20** (ft.) Flow Characteristics: **Fast**

Deposits: ☒ **None** ☐ Mud ☐ Sludge ☐ Debris ☐ Grease

Infiltration: **None** Pipe Seal Cond: **Unknown**

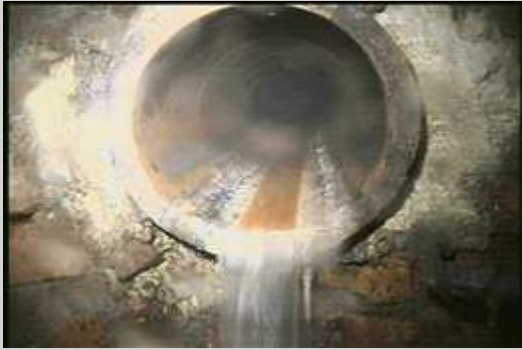
6 O'Clock Inflow

Infiltration: **None** Pipe Seal Cond: **Unknown**
